Manhole Inspection Summary

Manhole # S11MM_063MH

Location Address: **2921 GWYNNS FALLS**

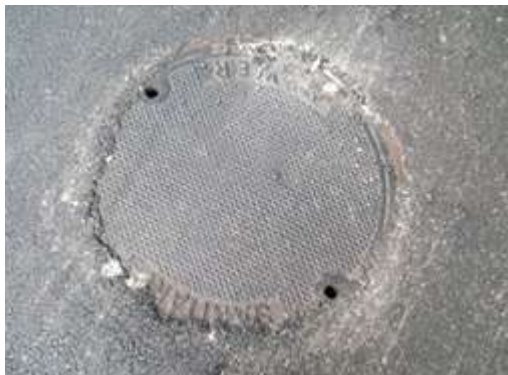
Defect 1

Cannot Access - Buried - Manhole Existence Confirmed by CCTV

Comments **Light visible; but MH was identified and it is paved over**

ASPHALT OVER MH COVER
